DEPARTMENT OF CONSERVATION

DIVISION OF MINES AND GEOLOGY

RE : INITIAL THREAT ASSESSMENT OF CLIFF RETREAT: ROUNDHOUSE CREEK
ROAD, BIG LAGOON PARK SUBDIVISION, TRACT 22, BLOCK A , HUMBOLDT
COUNTY, CALIFORNIA.

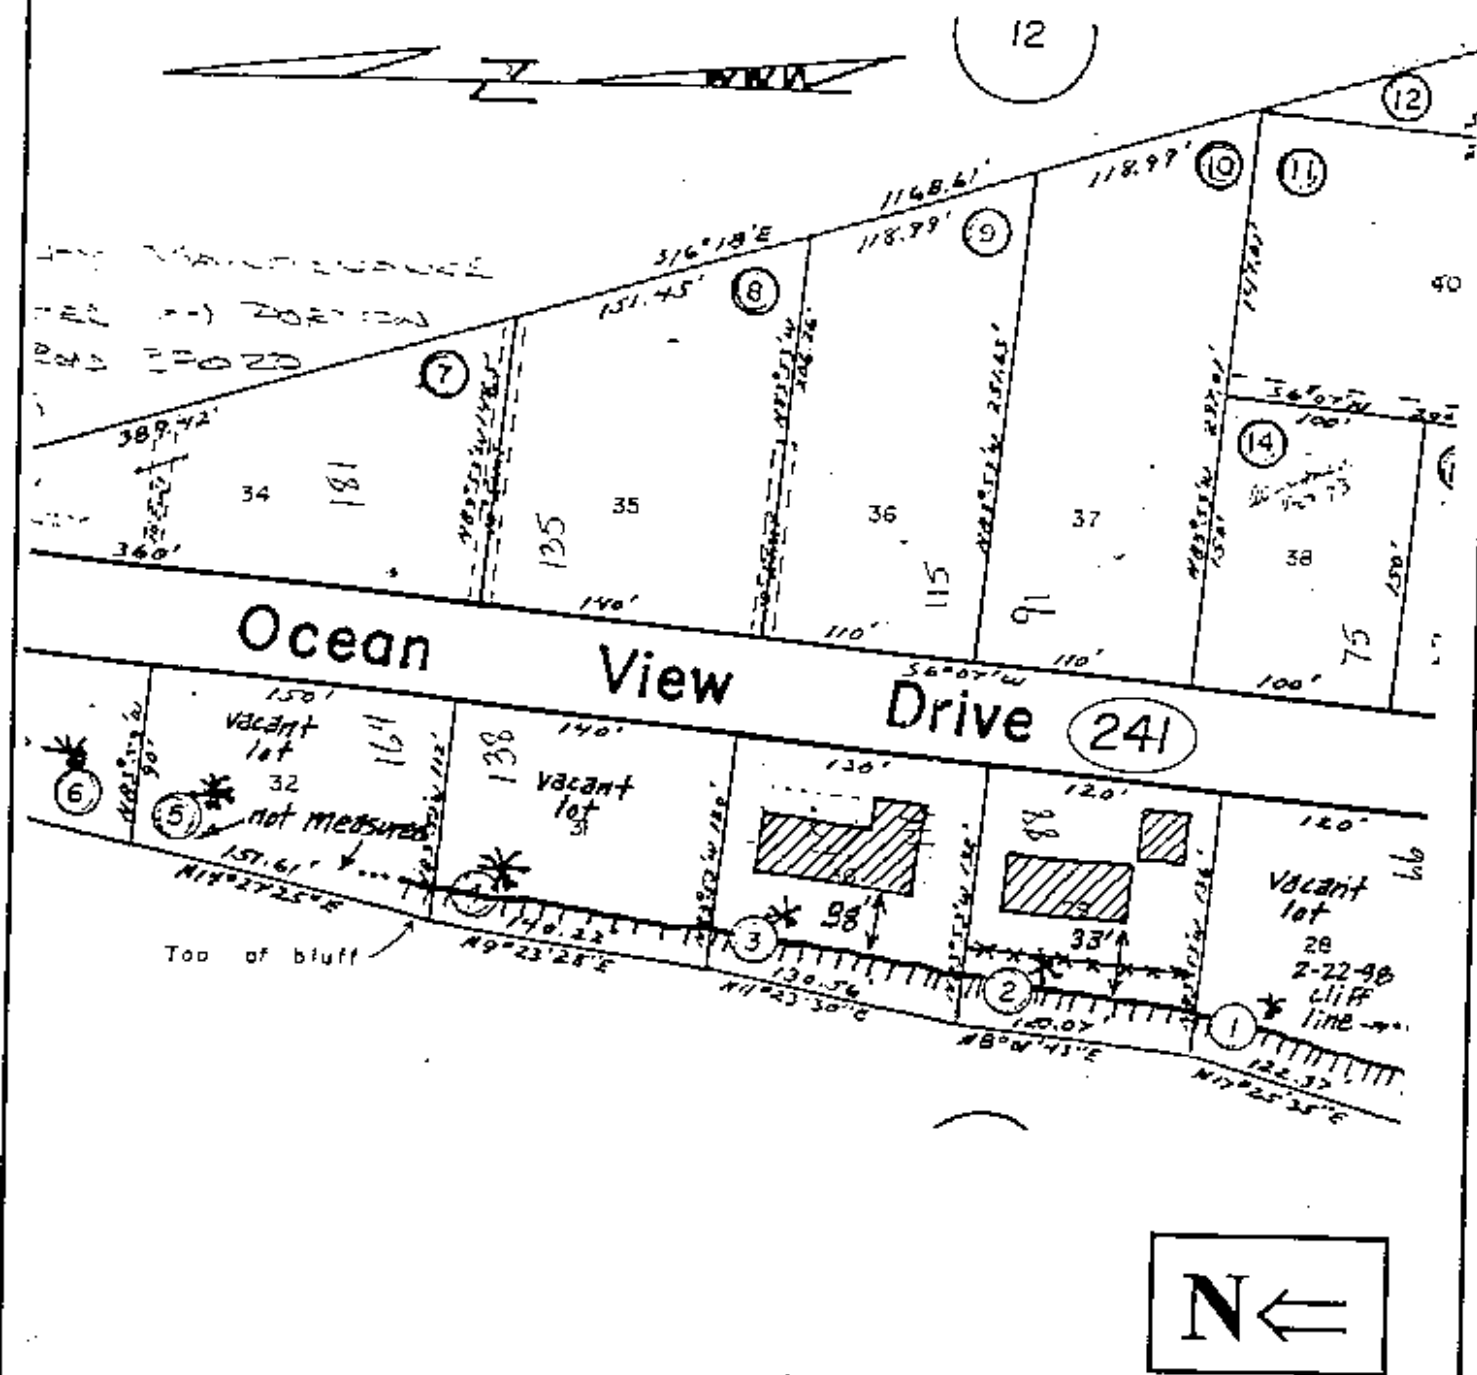
Site Location Map

- 1) The recent erosion begins near parcel 15 and extends north approximately 1/2 mile (see Figures 1 through 3).
- 2) The cliffs south of parcel 15 appear to be stable and have a well-developed, densely vegetated buttress of debris along the base. Only minor erosion (3 to 5 feet) was observed at the toe of the buttress during the site visit.

- 5) Cliffs up to 200 feet high exist on the southern end of Agate Beach near Patricks Point, and taper down to zero at the southwest corner of Big Lagoon (see Figure 1). Cliff height in the study area ranged from 25 to 90 feet.

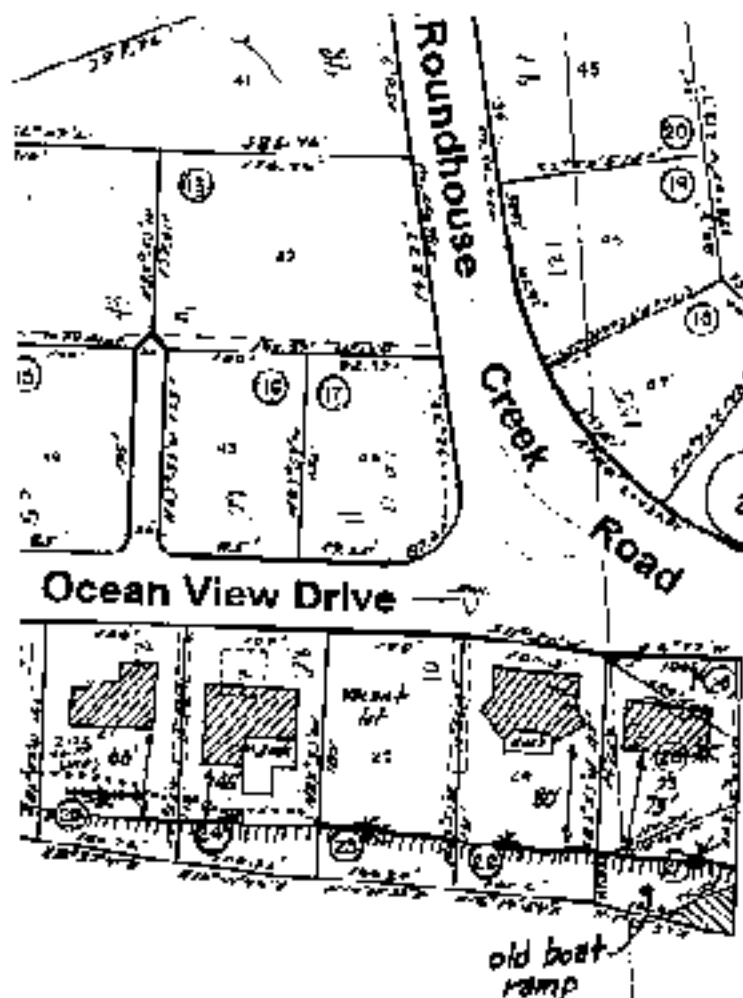
Assessors Map 1
To Accompany
Initial Threat Assessment of
Big Lagoon Cliff Retreat

Immediate Mitigation. The red and yellow tagging of structures by the county appears to be appropriate for the site conditions and observed failure rate. We understand that several other adjacent residences have been yellow tagged because of subsequent cliff retreat (see Figures 2 through 5).
